**MASTER PLAN
FOR
ENVIRONMENTAL MITIGATION
OF THE
METLAKATLA PENINSULA**

**FOR THE
METLAKATLA INDIAN COMMUNITY**

Revised January 1998

METLAKATLA PENINSULA MASTER PLAN FOR MITIGATION

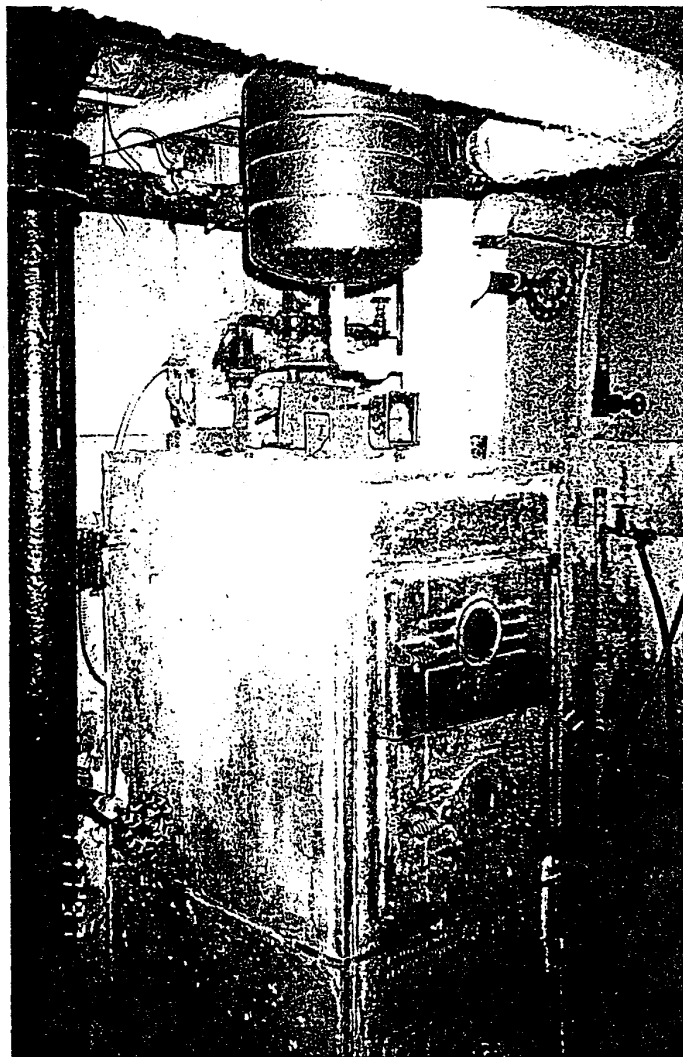
FAA Housing Boiler - Site 53.
Friable asbestos in thermal insulation,
and other asbestos containing materials
in boiler room of FAA housing unit.

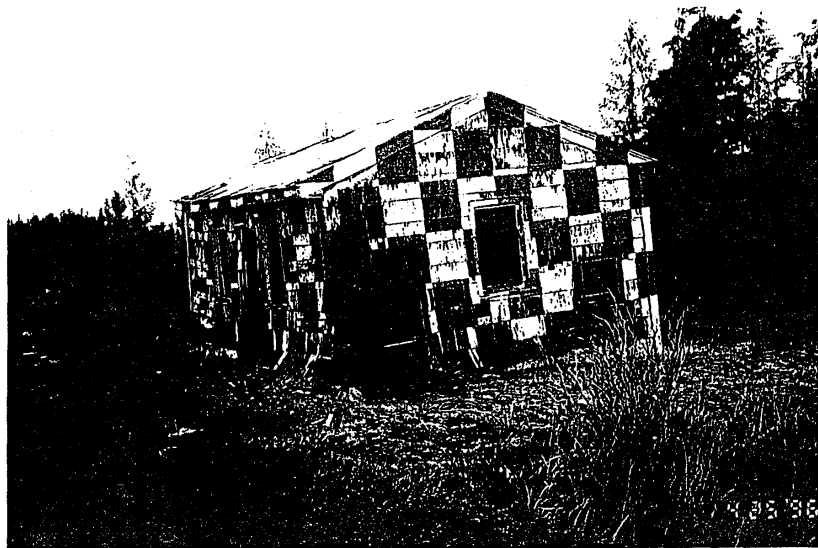
Localizer Building - Site 80.
Red and white lead-based paint flaking from exterior of
the Localizer building. Lead concentrations in soil
around many facilities exceed federal cleanup standards.

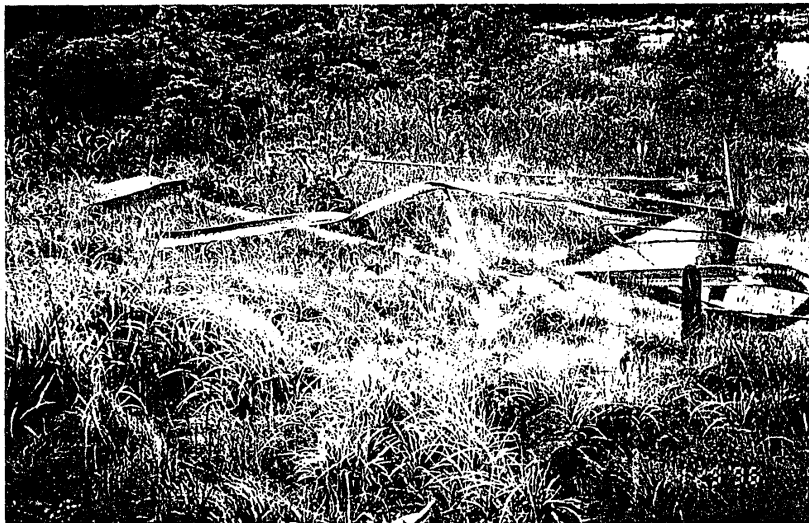
Site (Location)	MIC#	C3#	Background	Proposed Action	Cost
16 Antenna Towers (SSE of White Alice /Metlakatla Rd intersection)	16	-	Remains of 3-large orange and white towers (not standing)	C3: Included with airfield work?	
17 Beach Access Road	17	-	This 2,200' road was built sometime between 1961-1973 to connect Metlakatla Rd with Smugglers Cove.	Included in roadway work.	
18 Main Hospital Area (w. Tamgas Harbor, off of Hospital Road)	18	11	The Army constructed a 75-bed hospital for the Annette Landing Field. It was a Quonset hut facility, which was abandoned after the war. The site contains debris, metal huts, barrels, 55 gallon drums, electrical conduit; fuel in wood stove tank.	C3: Remove power house and UST's; remove 55 gallon drums and fuel tank; treat contaminated soil, remove debris.	\$380,000*
19 Non- Directional Beacon (end of Weather Bureau Rd above Boy Scout Beach)	19	12	The beacon site contains a total of five towers: one operating and 4 are on the ground. The FAA has a lease with the MIC for this facility.	C3: Remove towers and building; perform chemical sampling and remediate soils at tower location.	\$200,000*

Antenna Tower - Site 16.
Segment of an antenna tower with flaking lead-based paint.
The red and white paint on some of the antenna towers
contains more than 80% lead. Lead may be leaching into
ground water or surface water at this wetland site.

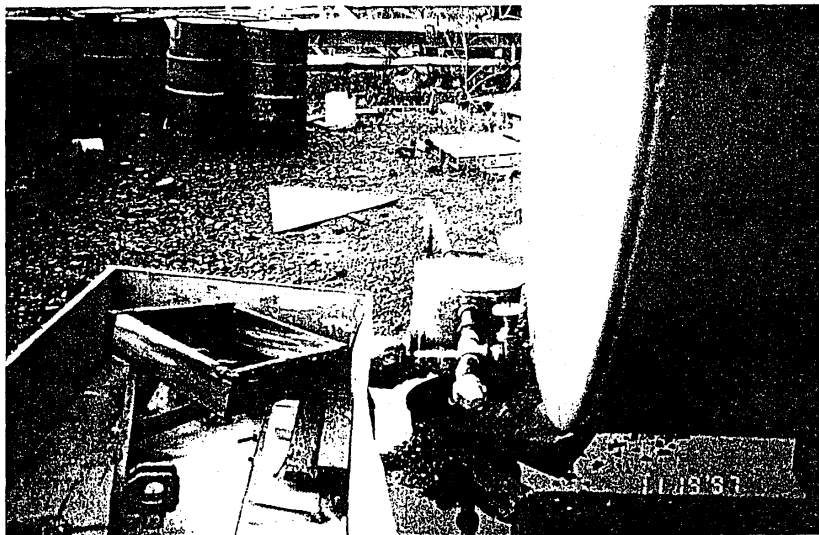
Site (Location)	MIC#	C3#	Background	Proposed Action	Cost
9 MPL Power Generation Plant	9	6	An Army plant was operated at this site prior to replacement by MPL Plant. The remains contain a metal building in an ~ 1.5 ac enclosed area. AST's, numerous 55-gallon barrels, machinery and debris are present.	C3: Chemical testing for PCB's, mercury, and other contaminants; treat contaminated areas; remove AST's and 55 gallon drums.	\$770,000*
10 Automobile Landfill (S side Quarry Rd, ~0.5 mi. e of Metlakatla Rd)	10	7	This closed dump originated as a military disposal site. The 0.35 ac site contains numerous 55 gallon drums, airplane parts, automobiles and large metal building construction debris.	C3: Remove and properly dispose of debris	\$270,000*
11 DoD Supply Dock (N. Tamgas Harbor, off of Quarry Rd)	11	-	The supply dock was the first dock constructed at the airbase for supplying material to the engineer's garrison and quarry. The dock rapidly deteriorated within a few years of construction because it was formed of untreated wood.	MP: Replace dock to allow shipping of metal debris for salvage/ recycling, and shipment of materials and supplies required for cleanup	\$2,200,000

BIA Power Generation Plant - Site 9.
Above-ground Storage Tank (AST) at former BIA power plant
leaking petroleum product onto the ground. All AST's sampled
lacked secondary containment, and soil samples taken near most
AST's contained levels of petroleum hydrocarbons and other
hazardous substances which exceed federal cleanup standards.

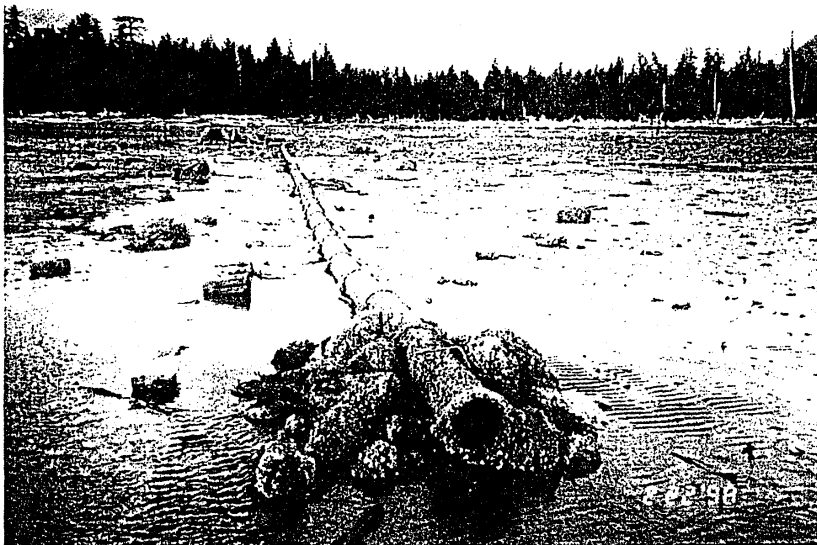
U.S. Coast Guard Housing Sewer Outfall - near Site 48.
This abandoned sewer outfall was associated with USCG
facilities near the former construction camp at Tent Point.
Several hundred feet of sewer line are visible at low tide,
as well as debris associated with former military use of the
area south of Tent Point.

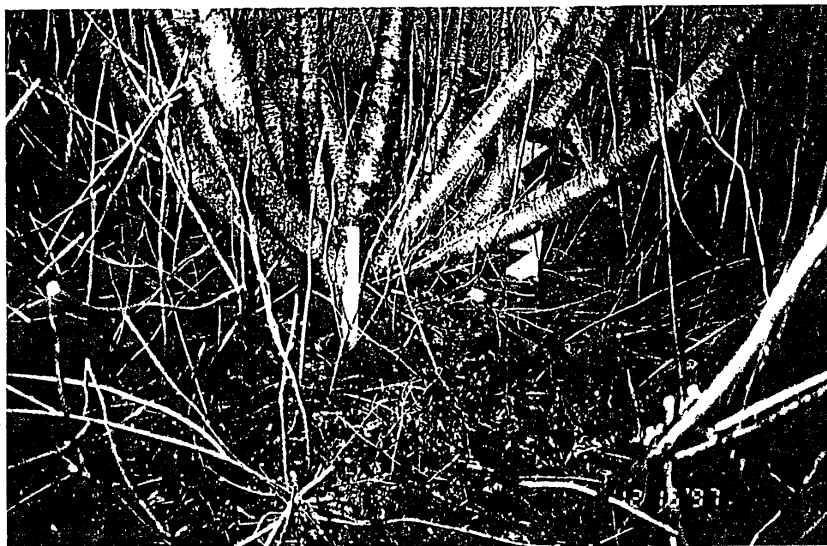
Air Traffic Control Tower - Site 78.
Tree growing around the fill pipe of a UST adjacent to the
former air traffic control tower south of the hangar.

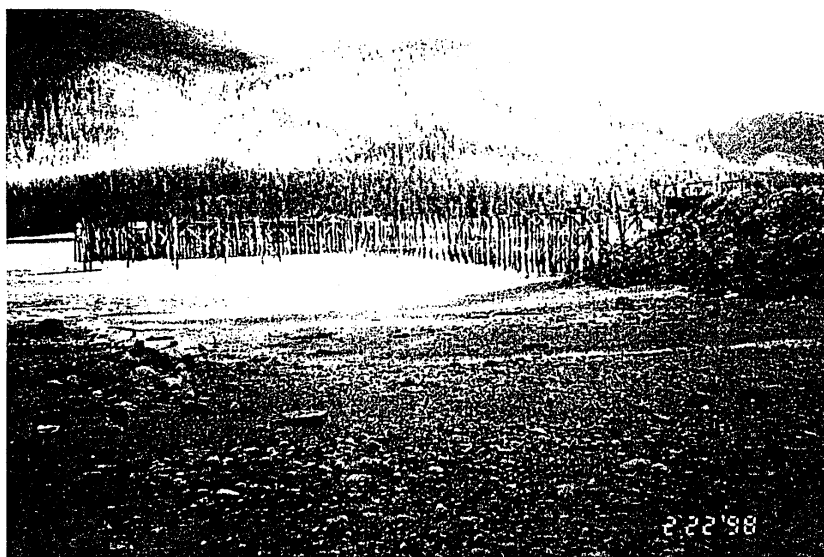
43 South Tamgas Harbor Dock (Main Dock)	43	29	This 800-ft long tanker dock served as a supply point and pipeline terminus for fuel loading. Much of the dock has collapsed. Debris and ordnance may have been dumped off the dock.	C3: Dive investigation off Main Dock for dumping of transformers, possible contaminants; Remove pipelines on dock; Remove Dock. MP: Refurbish dock to allow shipping of recyclable debris.	\$1,610,000*

DoD South Tamgas Harbor Dock - Site 43.
This dock once served as a supply point and a pipeline terminus
for fuel loading. Debris, ordnance, and chemical waste were
reportedly dumped into Tamgas Harbor off the end of the now
collapsed dock.

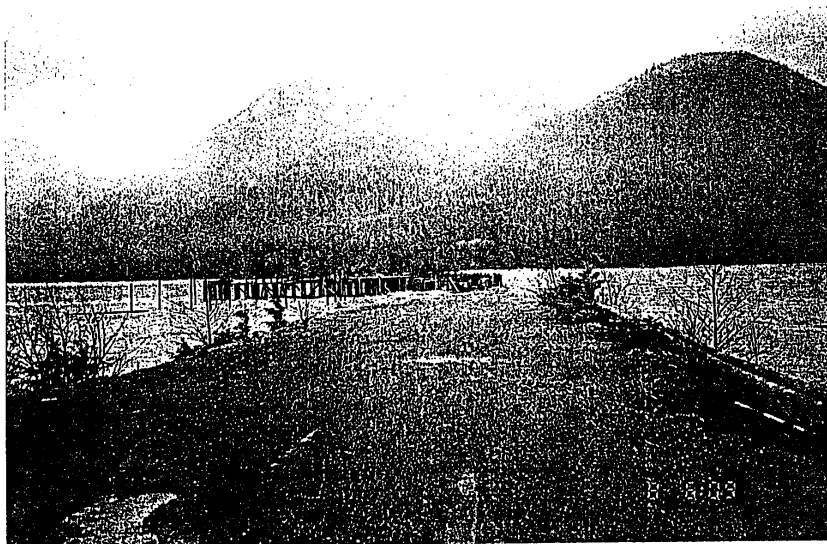
DoD South Tamgas Harbor Dock - Site 43.
The remains of the South Tamgas Harbor Dock and ramp. The
800 foot dock and ramp have eroded and collapsed in many
places and are no longer usable.

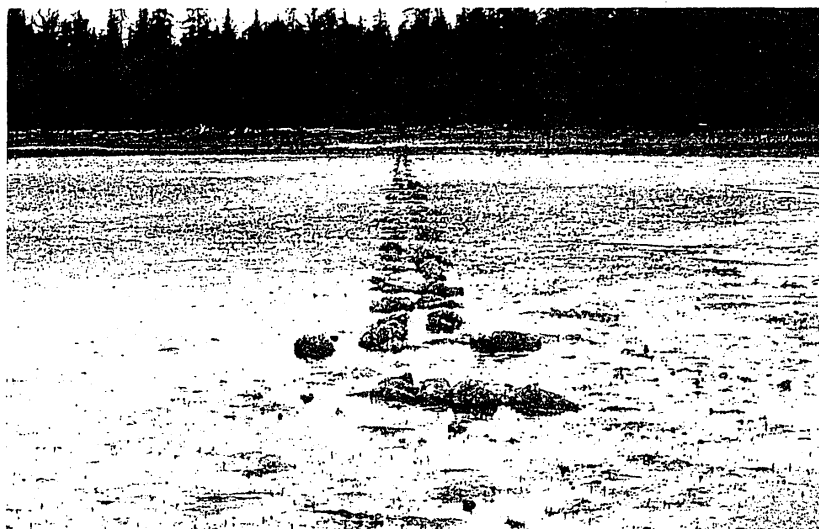
Hospital Sewer Outfall - Site 18.
At low tide the sewer outfall from the former DoD hospital
site can be seen extending from the beach onto tidal
flats in Tamgas Harbor.

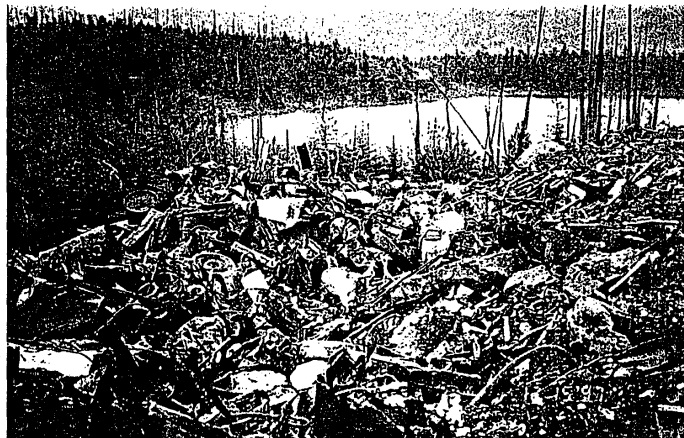
Former DoD Landfill - Site 10.
Runoff from this 2 acre landfill, which contains
numerous barrels and other metal, rubber, and
wood debris, drains directly to a fish-bearing
lake, approximately 250 feet downslope.

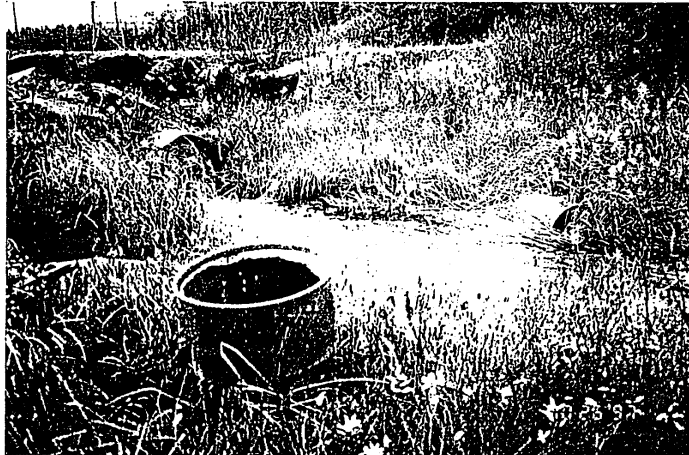
Gillnet Creek - near Site 24.
The Canoe Cover spur road to the Middle Marker Facility (Site 24) was constructed through Gillnet Creek, a salmon-bearing stream. The unpaved road contributes sediment to the stream, the culvert obstructs fish passage, and barrels and other debris impact instream and riparian habitat.

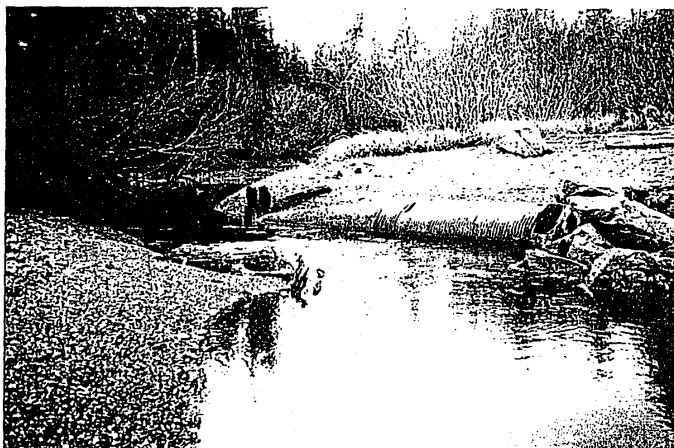
Colby Creek - near Site 18.

Colby Creek, an important salmon stream, runs through the former DoD Hospital area (Site 18) and enters Tamgas Harbor through a washed-out section of the former Hospital Road. The banks of Colby Creek are littered with World War II-era vehicles and other debris, and abandoned wastes near the old hospital site may be affecting water quality and impacting instream habitat.

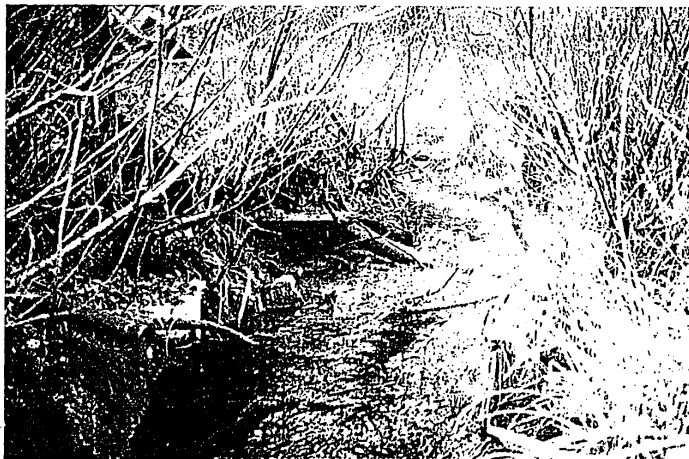
Annette Inn Creek - near Site 82.
Collapsed structures, septic lines, and other
debris from the former Winnipeg Garrison impact
instream and riparian habitat of Annette Inn Creek,
a salmon-bearing stream, approximately one-half mile
from its mouth.

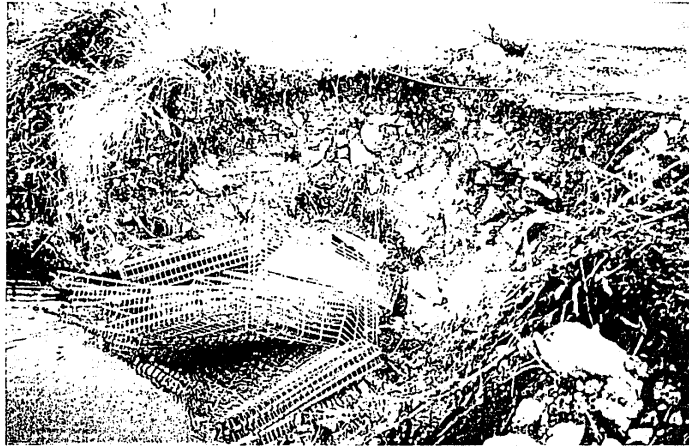
Moss Point Creek - near Site 33, Main Runway. Bank erosion and debris around the entrance of a culvert where the creek passes under the main runway. In this short segment between Airport Road and the runway, numerous discarded barrels are buried in the streambank and scattered in and along the stream.

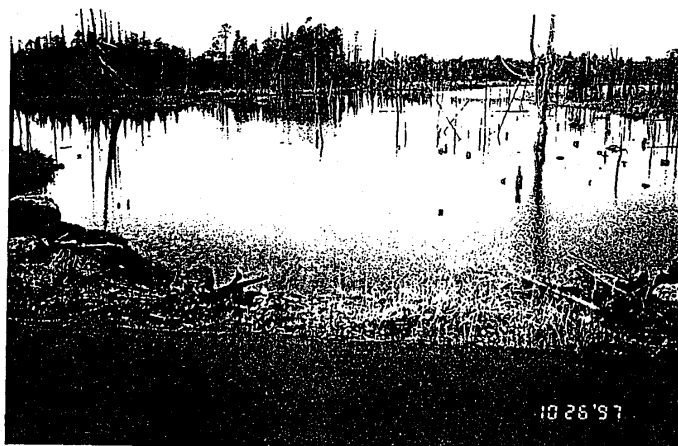
Moss Point Creek Headwaters - near Site 67.
Moss Point Creek is connected to this lake at its headwaters through a culvert under Airport Road. The natural flow and course of the creek have been significantly altered by construction of the road and landing field. As the creek passes under the road, the main runway and taxiways, and the B runway, it is exposed to contaminants in surface runoff.

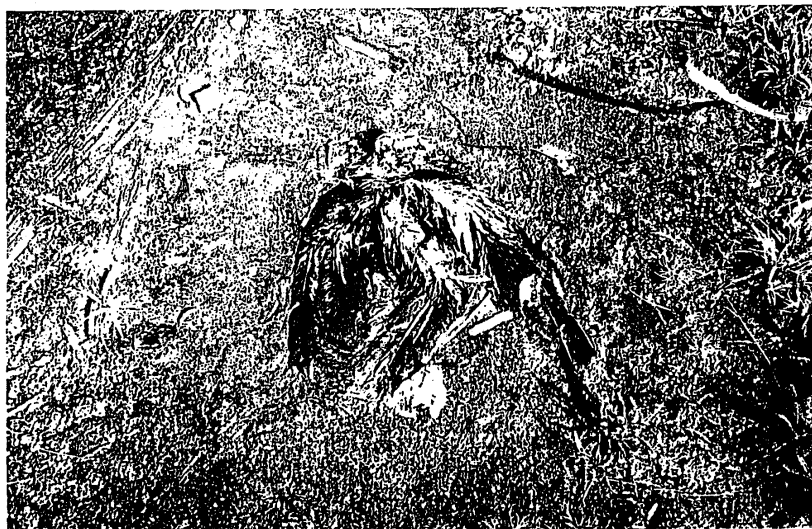
FAA Asphalt Plant - Site 37.

This raven became trapped and died in a pool of tar near the former Asphalt Plant used for runway paving operations. It is estimated that 10,000 to 30,000 drums of asphalt were used to pave the runway in the late 1940's, and numerous discarded drums and tar wastes still exist around this site.
